# **NPDES Inspection Report**

**Permit # WA0002062**

**Puget Sound Naval Shipyard**

**September 26, 2018**

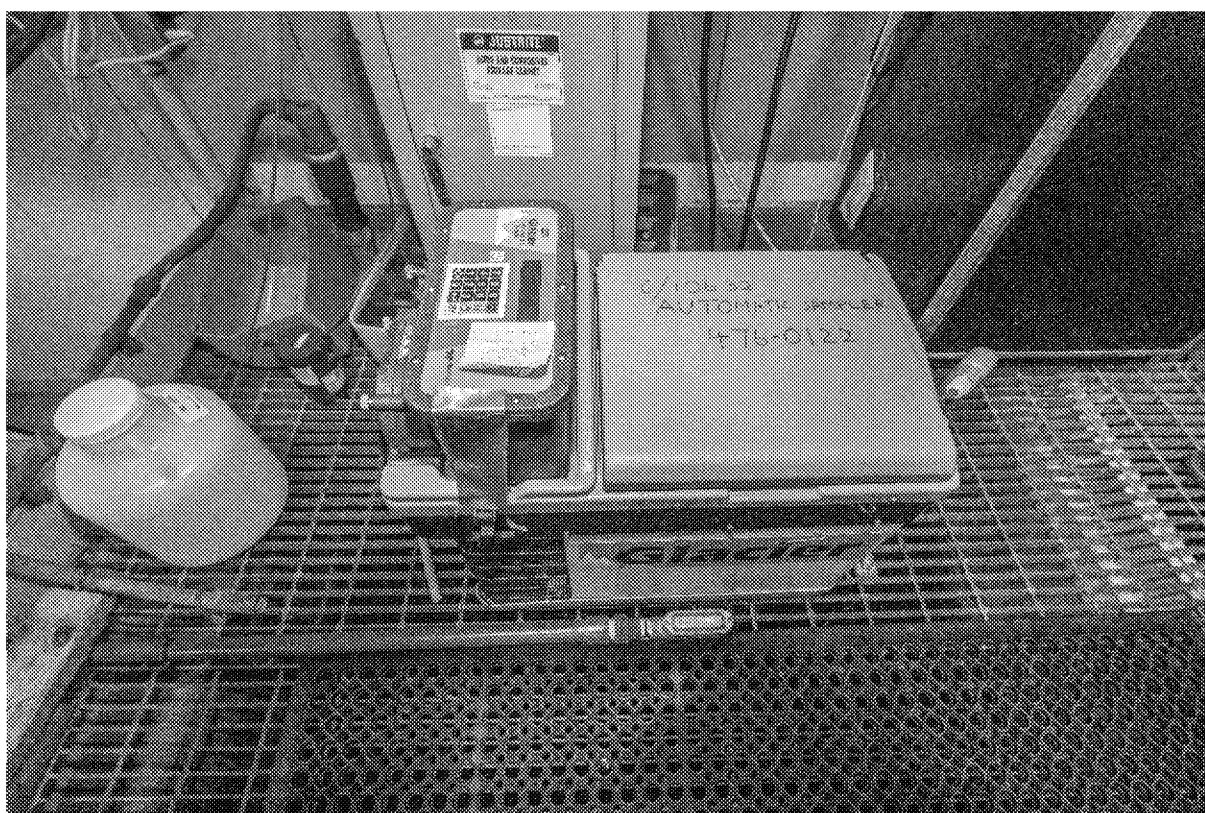
I visited the steam plant and inspected the sampling points for Outfall 021, consisting of a composite sampler (**Photo 1**) and grab sampling port (**Photo 2**). Mr. Richardson said that the facility plans to decommission Outfall 021 in 2019 after a planned facility upgrade that will direct all steam plant wastewater to the sanitary sewer system.

**Photo 1 / 18-1514-RELEASED-TVN-001** – Composite sampler at Outfall 021 at the Steam Plant

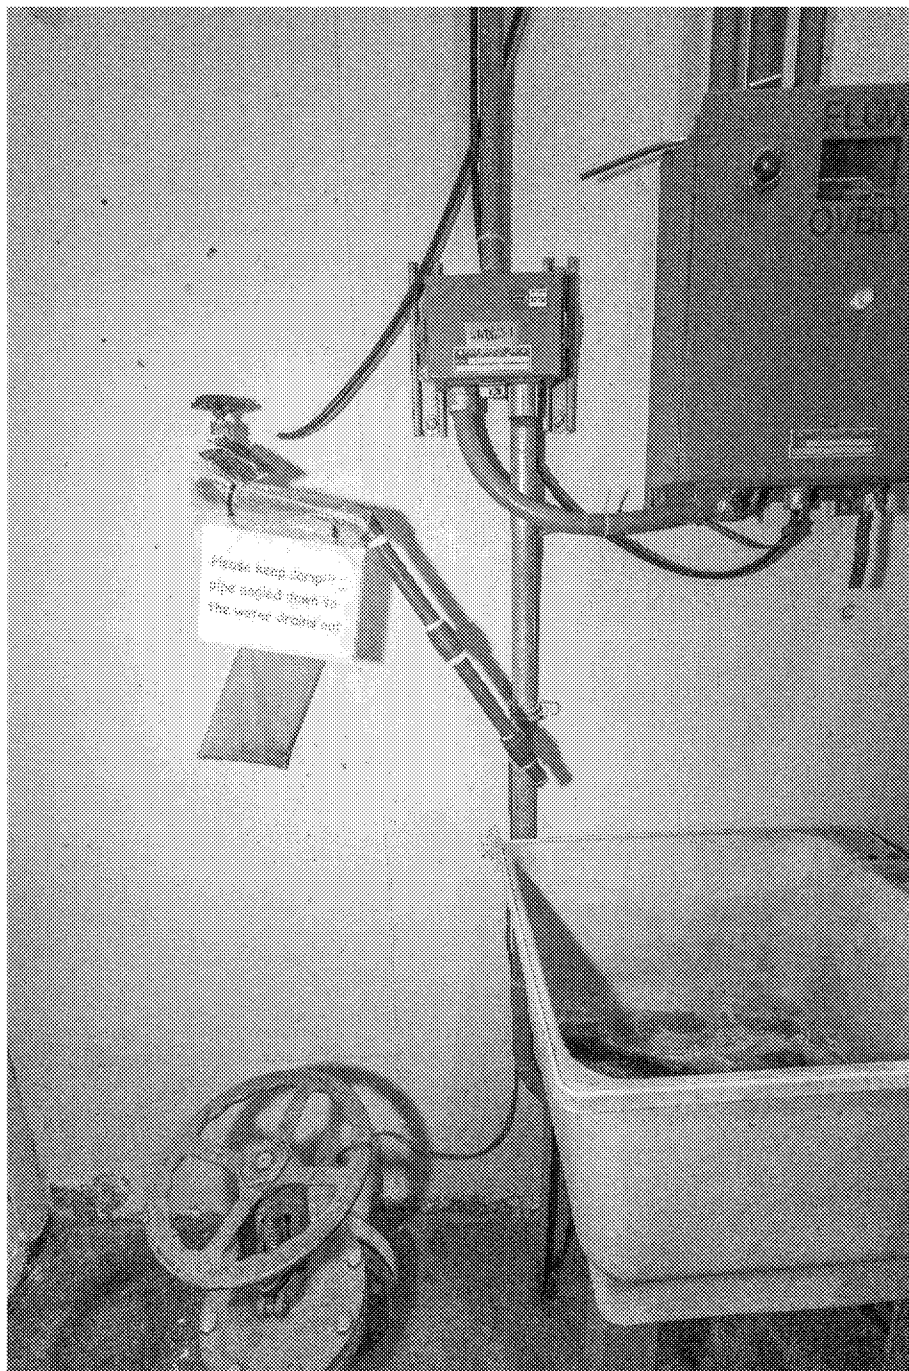
**Photo 2 / 18-1514-RELEASED-TVN-004** – Grab sampling port at Outfall 021 at the Steam Plant

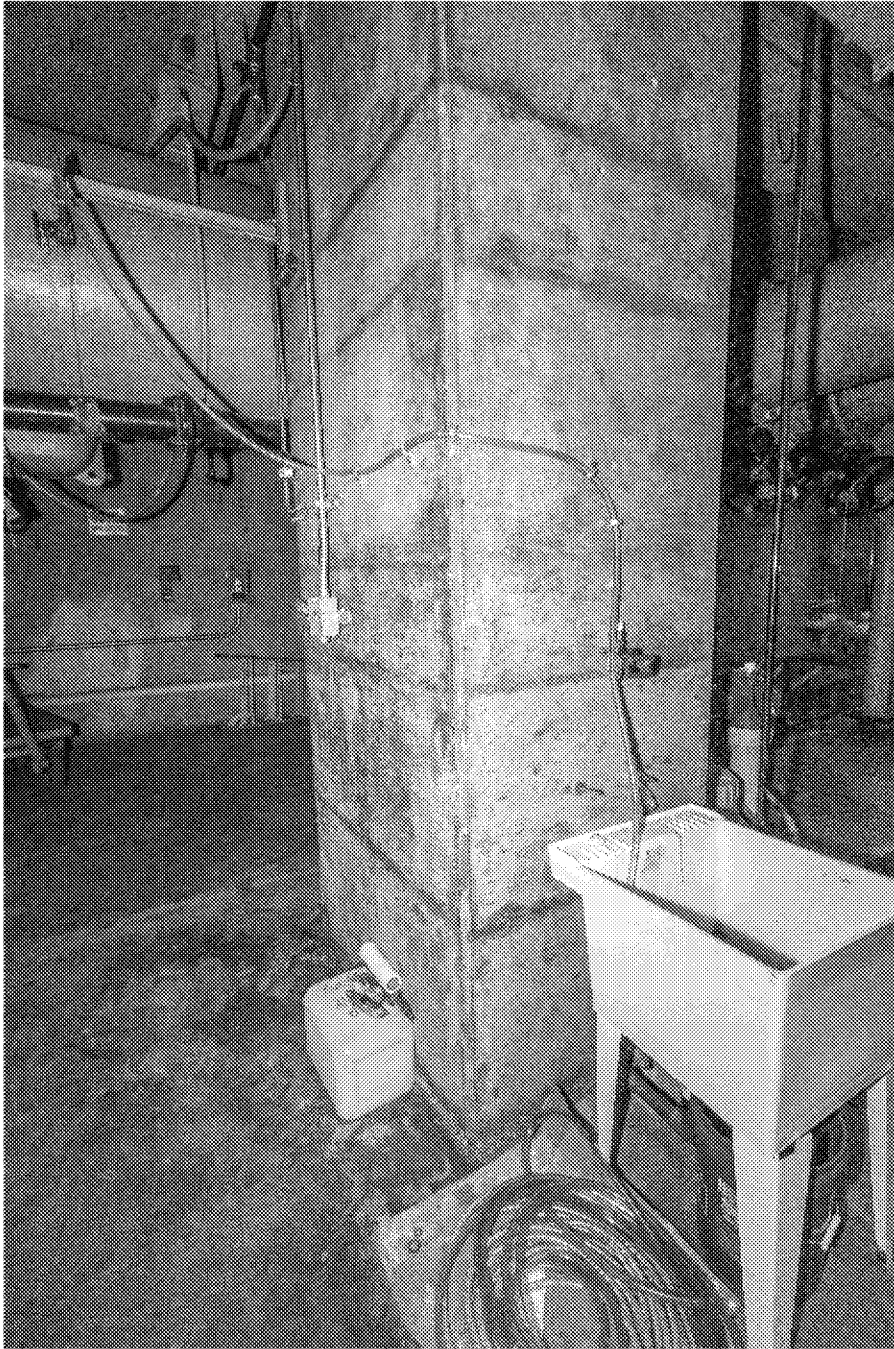
Outfall 019 is located at Drydock 6, which is the facility’s largest drydock. I inspected the sampling point at Outfall 019, which consists of a normally open valve connected to a long plastic tube (**Photo 3**) that drains to a utility sink. Mr. Richardson said that the facility replaces the tube approximately once per month.

I noted that the facility uses a long plastic tube (**Photo 3**) to collect grab samples for oil and grease at Outfall 019. Although I have not found this technique specifically discussed in approved sampling methods for oil and grease, I noted that the potential for extractable matter to adhere to the plastic sampling tube, combined with the facility's practice of replacing this tube on a monthly basis, could result in measurements that are biased low and not representative of the monitored discharge.

**Photo 3 / 18-1514-RELEASED-TVN-005** – Sampling tube for Outfall 019 at Drydock #6
